Preserving History in Two Counties and Three Towns

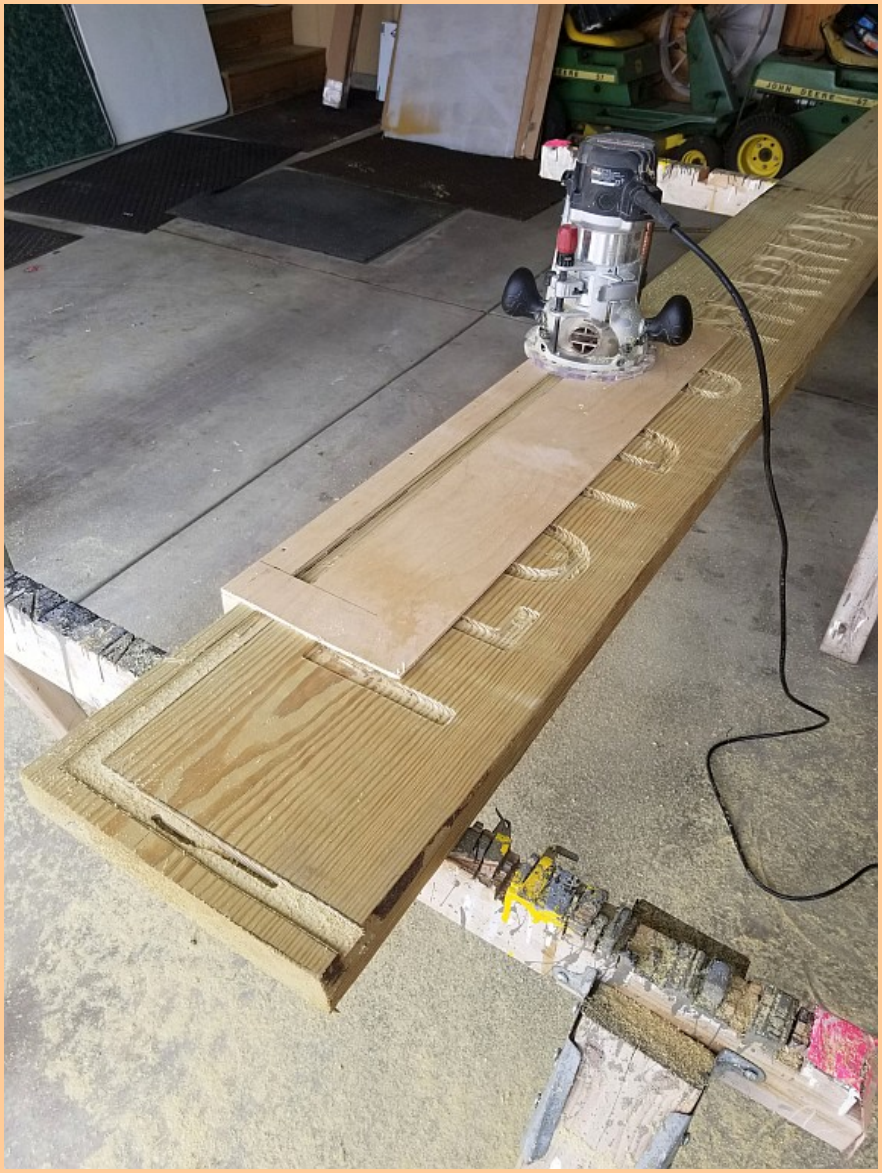
Routed letters and border in my Fairbury garage ☺

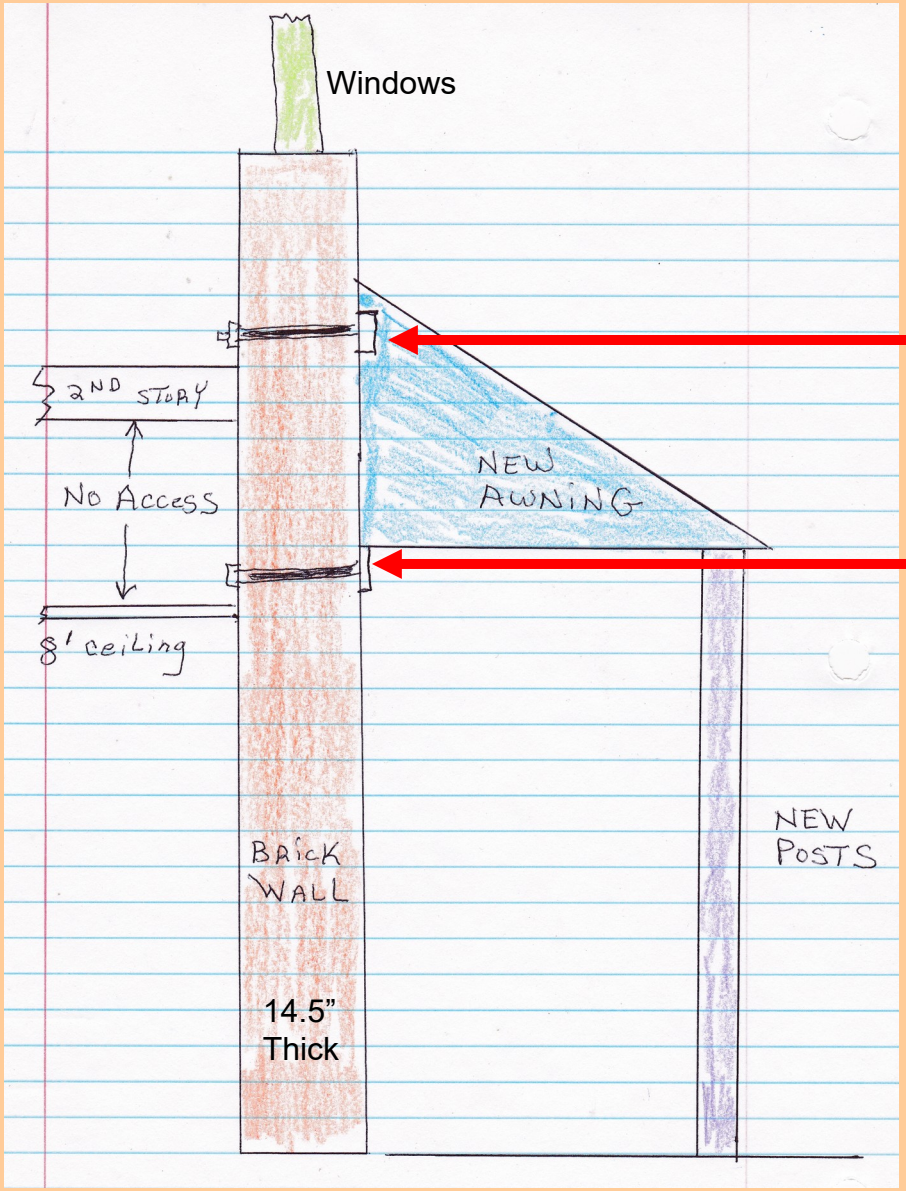
How to support new trusses on the brick wall?

Old 2x6" wood plate & bolts thru brick wall

"Ideal" location for new wood plate to support trusses, but no access to put in the bolts thru brick wall???

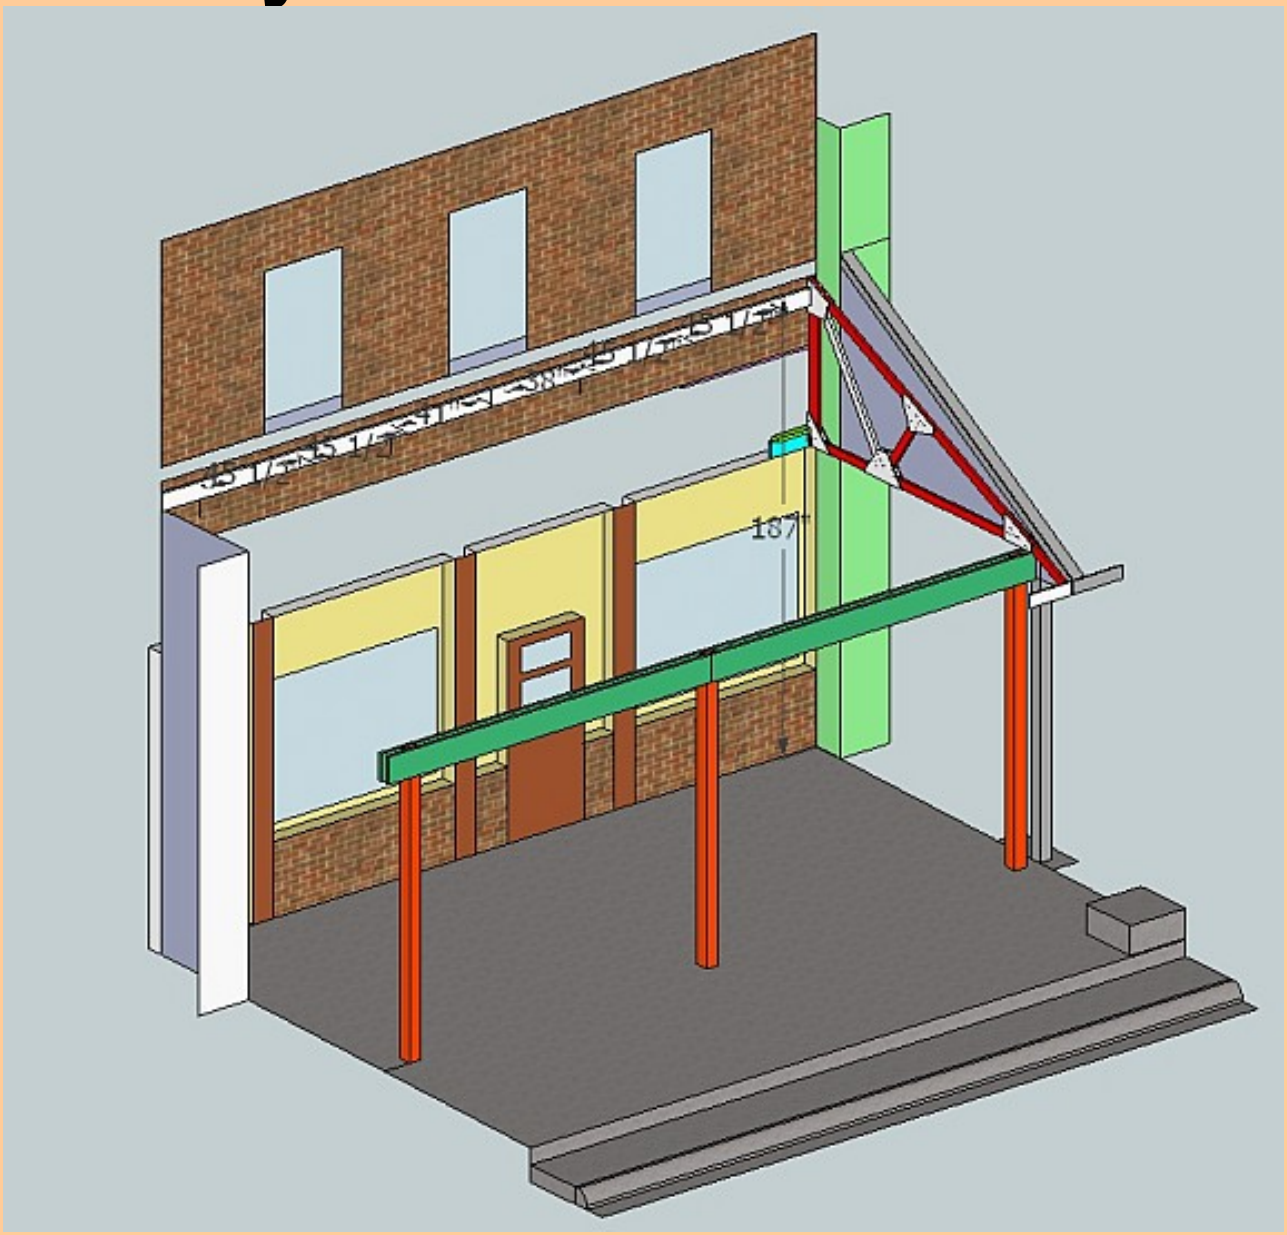
Ready for Trusses ☺

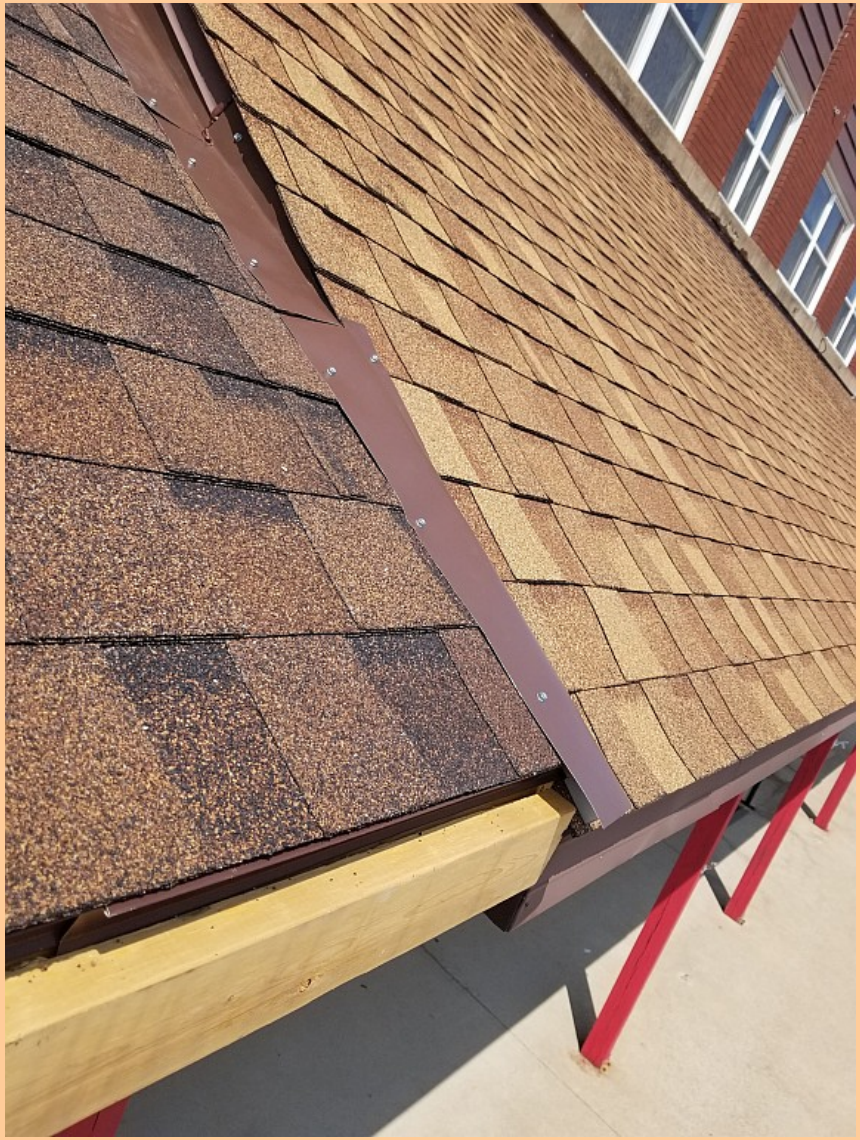
- Roofs at 2 different angles !

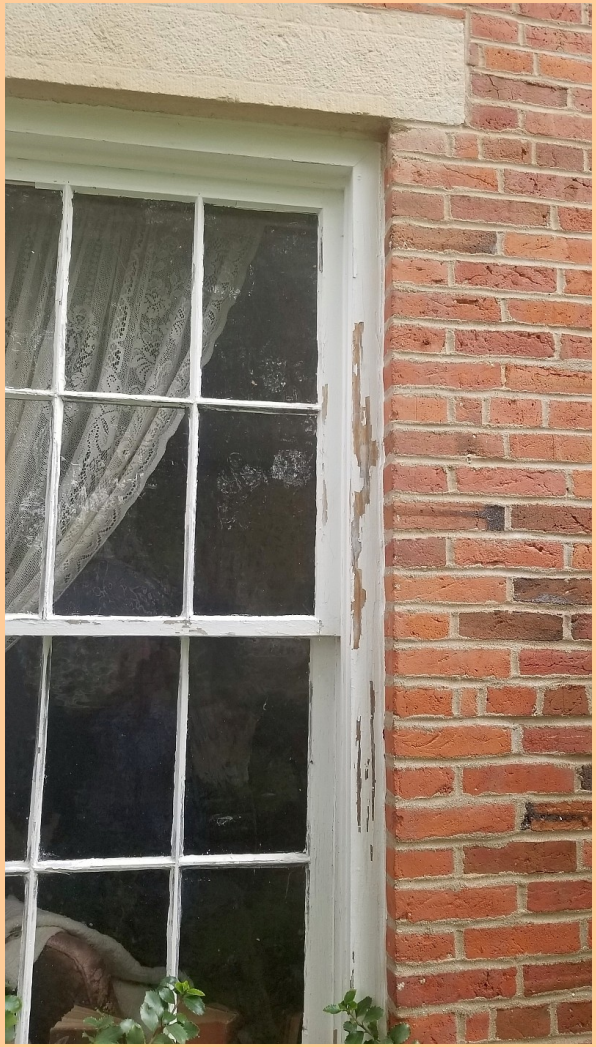
Before

After
